Final report of the BDIZ EDI implant study 2014/15

SEM surface analyses of 120 sterile-packed implants

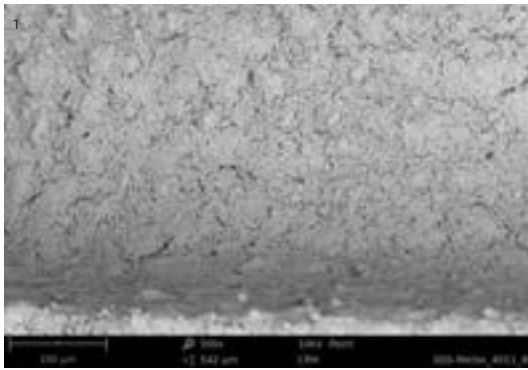
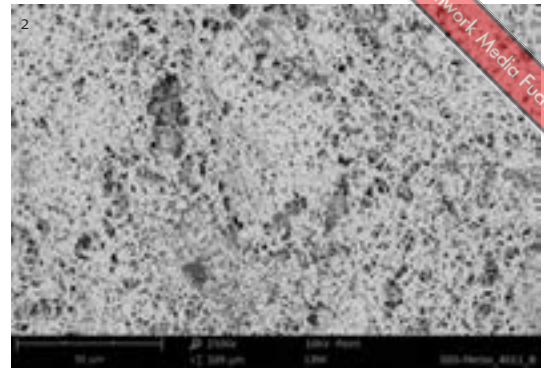
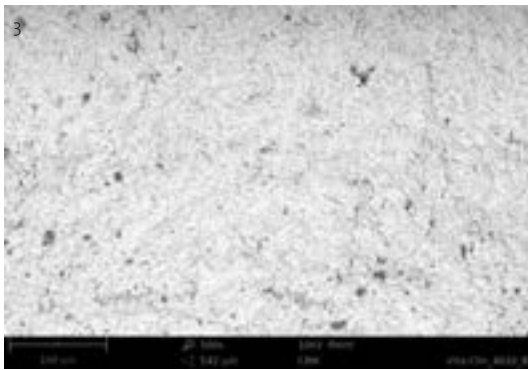
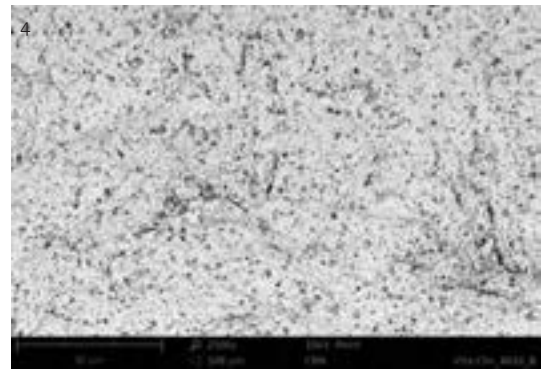
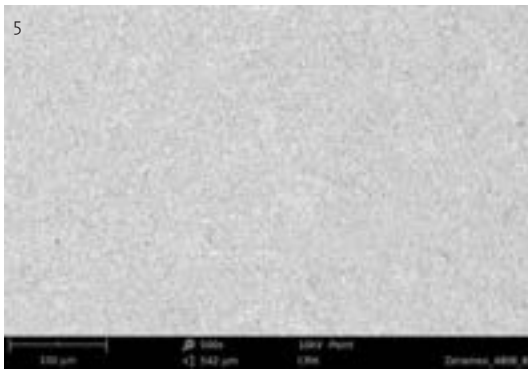
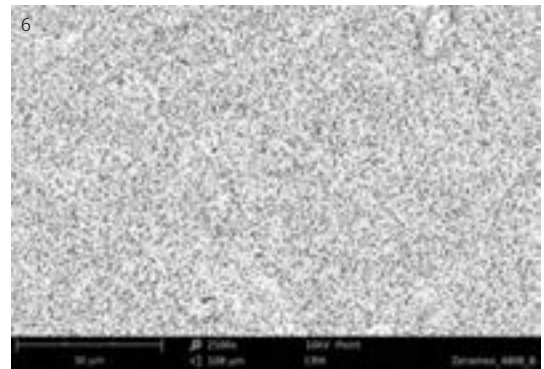
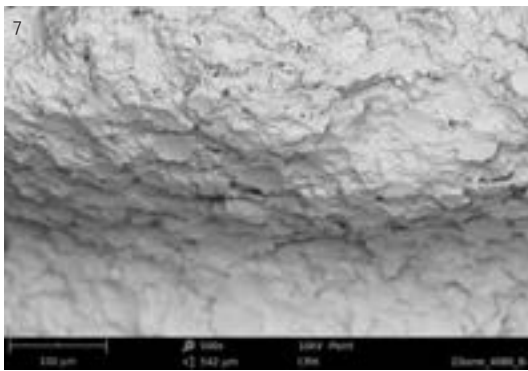
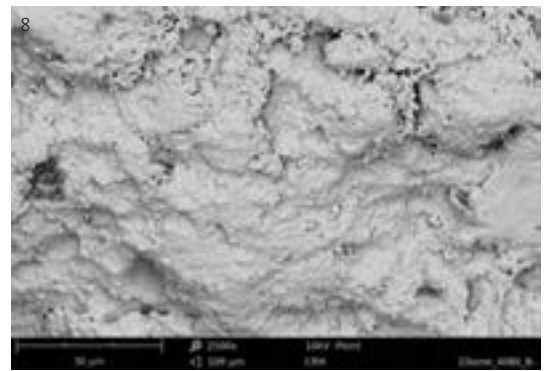
1 |
SDS – Metoxit
(x500).

2 |
SDS – Metoxit
(x2,500).

3 |
vitaclinical
(x500).

4 |
vitaclinical
(x2,500).

5 |
Dentalpoint –
Zeramex (x500).

6 |
Dentalpoint –
Zeramex (x2,500).

7 |
Zibone – Coho
(x500).

8 |
Zibone – Coho
(x2,500).

integration potential [8]. The surfaces exhibit different levels of roughness (Figs. 1 to 16).

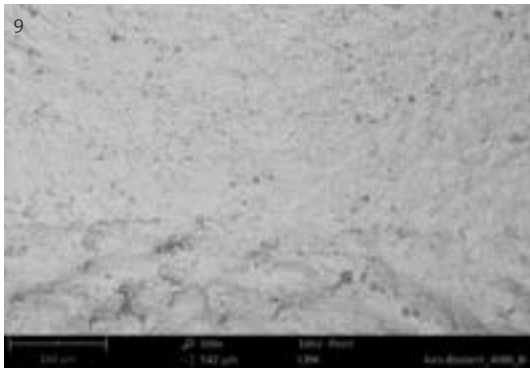
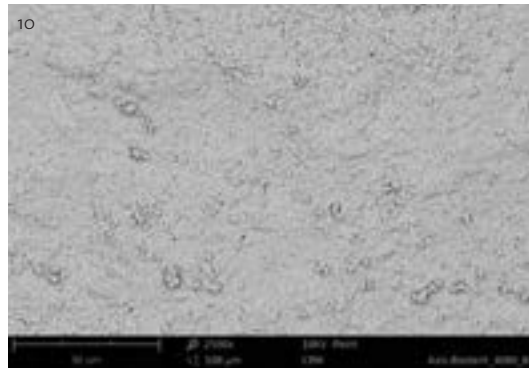
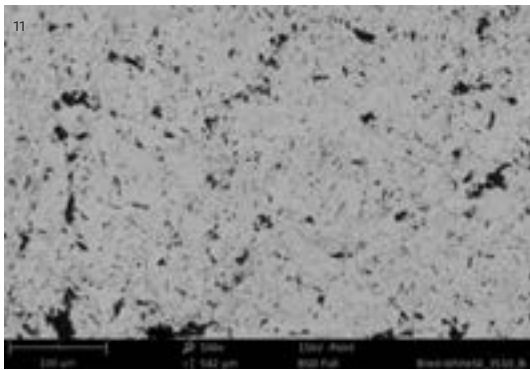
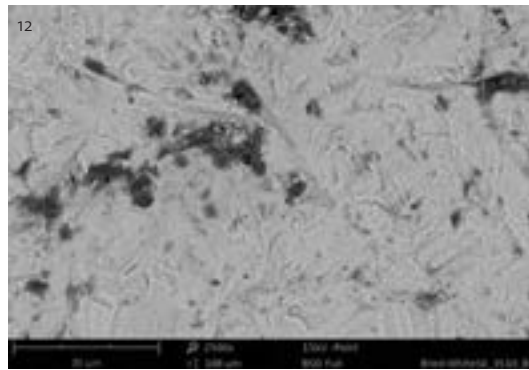
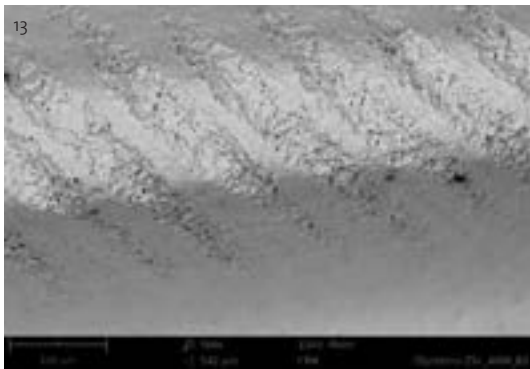
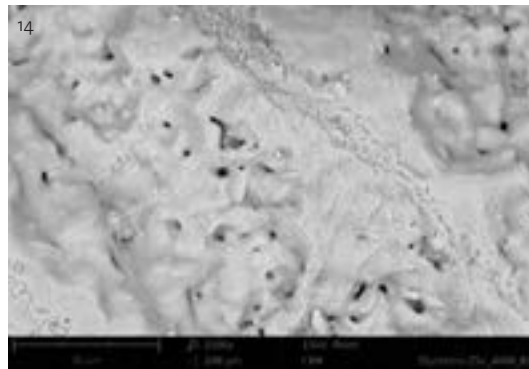
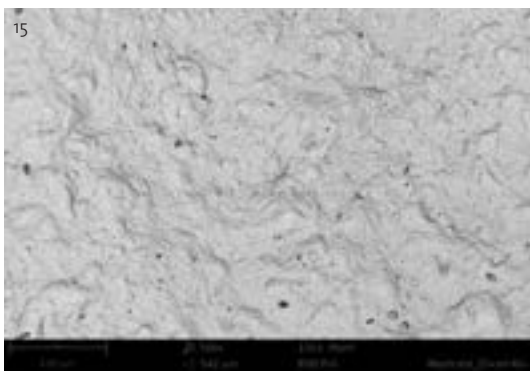
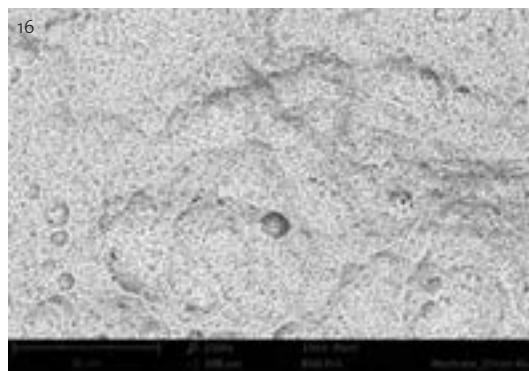
9 | Axis – biodental (x500).

10 | Axis – biodental (x2,500).

11 | Bredent – WhiteSky (x500).

12 | Bredent – WhiteSky (x2,500).

13 | Z-Systems – Zirkolith (x500).

14 | Z-Systems – Zirkolith (x2,500).

15 | Natural Dental Implants – root-analogue replicate made entirely of zirconia (x500).

16 | Natural Dental Implants – root-analogue replicate made entirely of zirconia (x2,500).

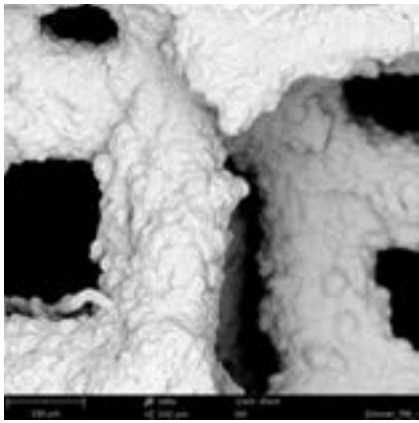
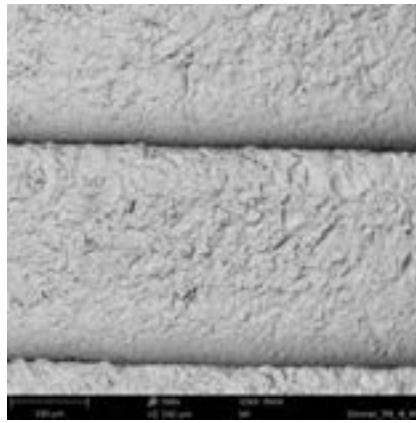
17 | Trabecular midsection made of tantalum (Zimmer Trabecular Metal implant, x500).

18 | The shoulder and apex of the same implant are made of titanium (Zimmer Trabecular Metal implant, x500).

One tantalum-titanium hybrid implant in this study exhibited a rather particular surface topography. While the titanium surface of the implant shoulder and its apical region had been blasted with hydroxyapatite, the middle segment of the implant, marketed by the manufacturer as “trabecular metal”, had a porous structure not unlike cancellous bone. This three-dimensional structure is based on a glassy carbon framework completely coated with tantalum. The corrosion-resistant tantalum [11] has been successfully used as an orthopaedic implant material for many years. Now also used in dental implants, the special surface texture is designed to allow the ingrowth of bone cells into the depth of the structure [12,13]. The term “osseoincorporation” has been coined in the literature in an attempt to add a third dimension to *Brånemark's* definition of osseointegration [14]. Prospective multicentre studies at 22 locations in five European countries have shown that the clinical success rates of hybrid implants made of titanium and tantalum were similar to those of pure titanium implants [15]. The only representative of this class of materials in the cur-

rent study was the tantalum-titanium hybrid implant by Zimmer (Figs. 17 and 18).

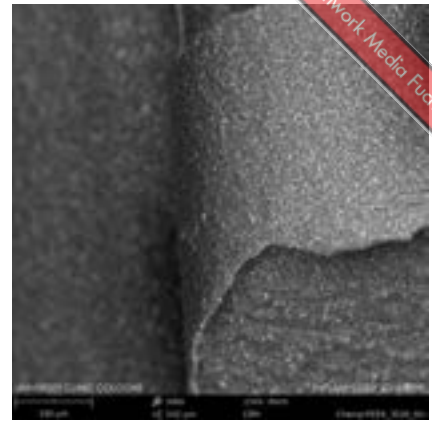
19 | Implant made of polyether ether ketone (Champions WIN! PEEK implant, x500).

Polyether ether ketone (PEEK) has more recently been used as a new material for dental implants (Fig. 19). As the material has only been used for dental implants for a rather short time, only few reports are extant. In-vitro trials suggest that the mechanical properties of PEEK might optimize the distribution of masticatory forces through the implant's surroundings [16,17]. Here we will have to wait for long-term clinical results. Only one implant made of PEEK was included in the study; a second manufacturer had not responded to our enquiries.

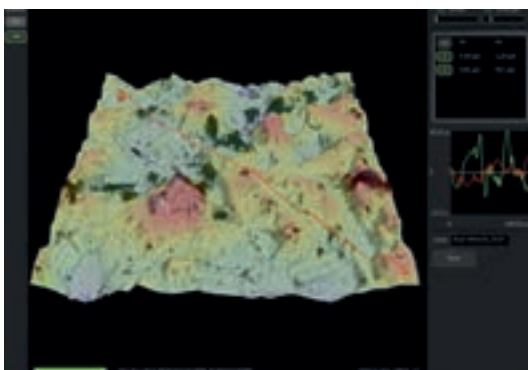
20 | 3D roughness reconstruction (Bredent WhiteSKY, x2,500).

To document the surface roughness of each of the investigated implant systems, a so-called 3D roughness reconstruction was performed that allows a visual comparison of the respective surface structures. During the imaging process, the three-dimensional shape of the object is calculated from the brightness distribution in the grid of the four quadrants of the backscattered electron detector (Fig. 20).

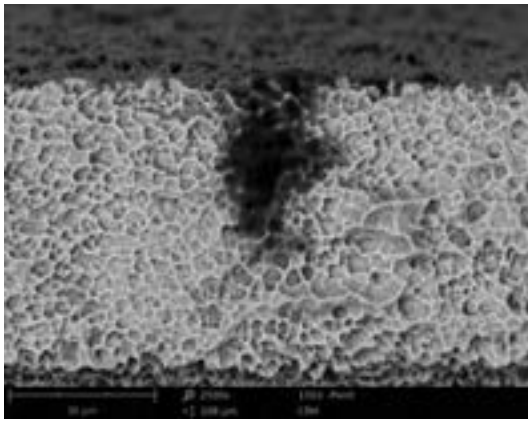
21 | "Single spot", individual organic contaminant (x2,500).

Minor amounts of carbonaceous residue remaining on the implant after the cleaning process are a not infrequent finding. Organic residue appears darker in the material contrast image than titanium or zirconia because carbon atoms have fewer electrons and therefore create fewer backscattered electrons in a SEM than atoms of higher atomic numbers. Soft, sometimes jagged edges are typical of organic contaminants. If there are only a few isolated spots like that, they will make up only a very small part of the total area, being of little consequence and no clinical relevance (Fig. 21). The figure shows a single organic impurity 10 to 20 μm in size on an otherwise largely residue-free implant. More conspicuous were systematically distributed organic residues on several implants that are in contact with their outer packaging. These typically featured circumferential organic contamination occurring only at the outer edge of the thread (Figs. 22 to 24),

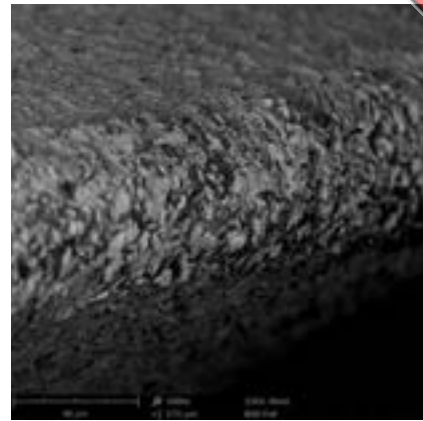
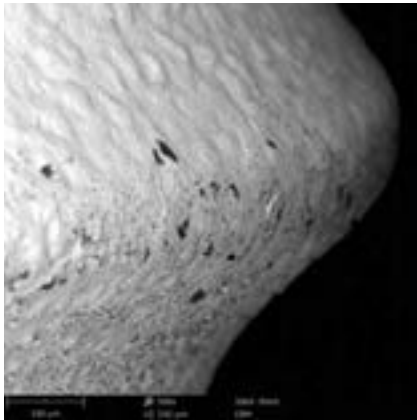
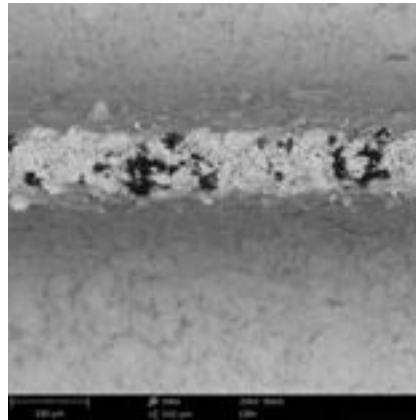
22 | Circumferential organic residue on a titanium implant (x500).

23 | Organic residue on the outer thread structures (zirconia, x500).

24 | Superficial organic particles (zirconia, x500).

which suggests that contact with the packaging could be responsible.

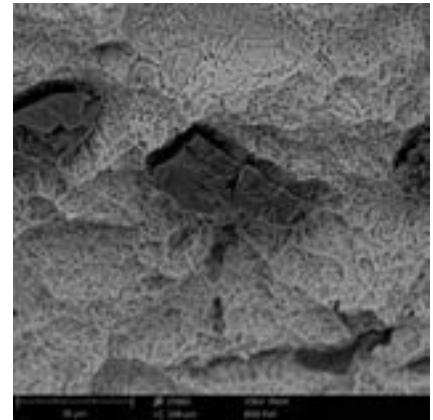
25 | Individual inclusions of sandblasting material (titanium, x2,500).

Some isolated implants exhibited inorganic residue from the sandblasting process, namely alumina particles 20 to 30 μm in size (Fig. 25), but in quantities of presumably limited clinical relevance.

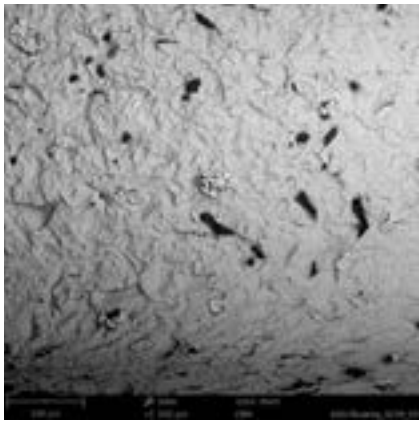
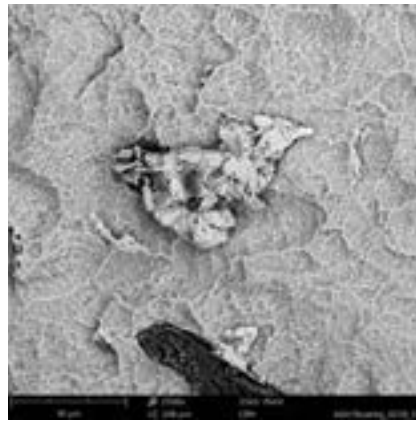
Unexpected inorganic residue findings included, in addition to the iron-copper-chromium particles described in the first part of the report, larger areas with intermittent chromium-nickel-steel particles 4 to 30 μm in size on one of the implants studied. The material contrast image had already presented them as strikingly bright and well-defined structures. These metallic particles might have originated as impurities within the blasting material or as abrasion residue from the CNC cutting tools that were subsequently embedded in the implant surface to the point where cleaning could not remove them (Figs. 26 and 27). Three spot analyses were carried out as part of the qualitative and quantitative elemental

26 | Implant surface (Adin Touareg) with notable light and dark particles (x500).

27 | Same implant surface (Adin Touareg): bright chromium-nickel-iron particle, dark aluminium oxide particle (x2,500).

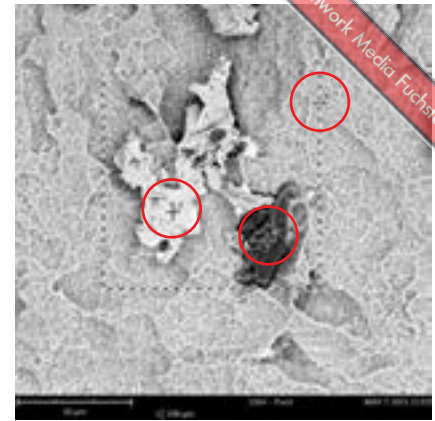
28 | Marks for EDX spot analysis and EDX mapping area (Adin Touareg; x2,500).

analysis (Fig. 28). The analysis of the chromium-nickel-steel particle (spot no. 2) has typical “fingerprints” for the elements iron, nickel and chromium (Fig. 29 and Table 2). As expected, the dark particle turns out

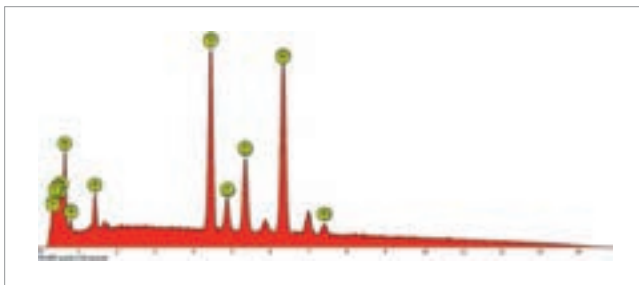
29 | Qualitative elemental analysis, spot no. 2 (bright chromium-nickel-iron particle).

Element	Atomic percentage	Certainty
Fe	49.8%	0.99
Ti	24.5%	0.99
Cr	13.6%	0.99
Al	5.6%	0.97
Ni	5.2%	0.96
V	1.3%	0.94

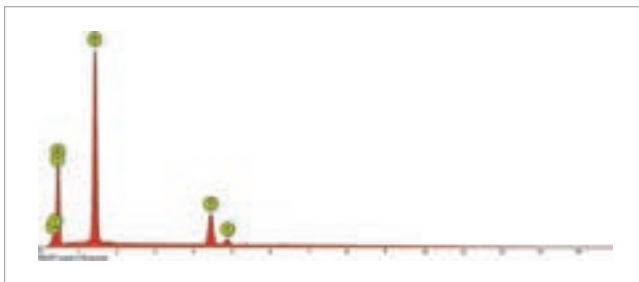
30 | Qualitative elemental analysis, spot no. 3 (bright aluminium oxide particle; sandblasting residue).

Element	Atomic percentage	Certainty
O	68.2%	0.99
Al	25.3%	1.00
Ti	6.1%	0.99
V	0.4%	0.93

to be alumina (Fig. 30 and Table 3), while the control area outside the two particles (spot no. 4) shows only the typical signs for grade 5 titanium (titanium, aluminium and vanadium) (Fig. 31 and Table 4).

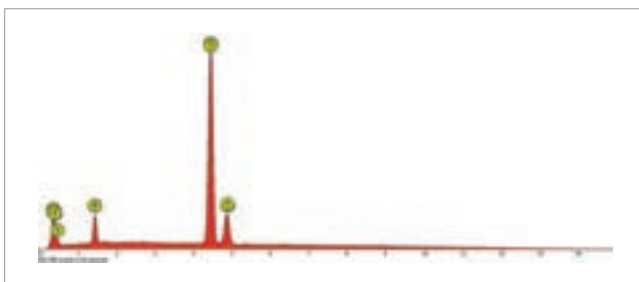
31 | Qualitative elemental analysis, spot no. 4 (particle-free implant surface, grade 5 titanium).

Element	Atomic percentage	Certainty
Ti	85.7%	1.00
Al	11.5%	0.99
V	2.8%	0.94

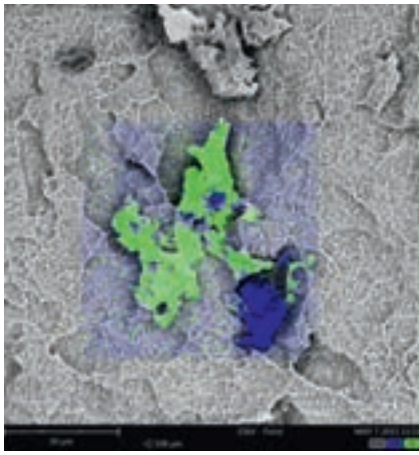
32 | Example of EDX mapping; green = chrome; blue = aluminium (Adin Touareg; x2,500).

The so-called EDX mapping assigns each elemental signal its own colour, which can then be superimposed on the SEM image as a coloured overlay. Figure 32 shows the detected chromium in green and aluminium in blue.

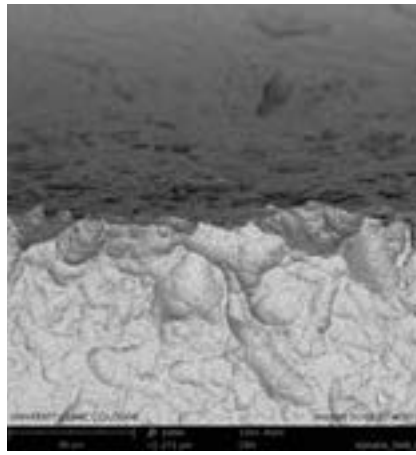
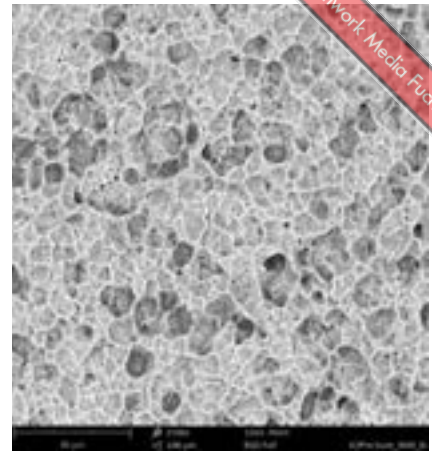
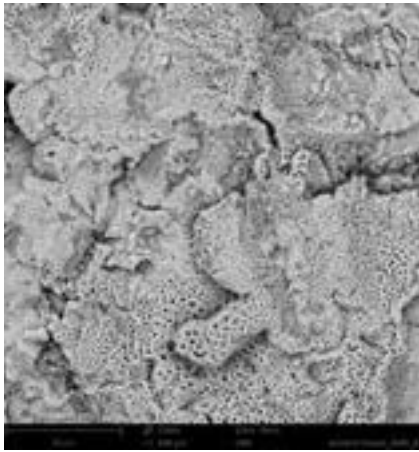
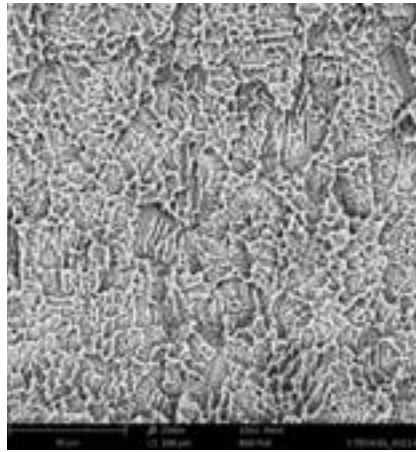
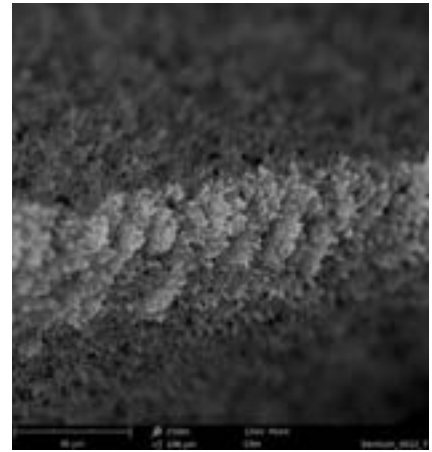
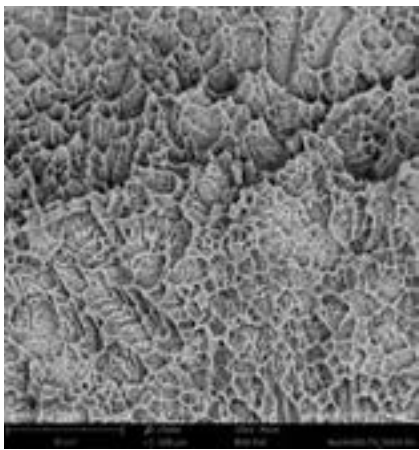
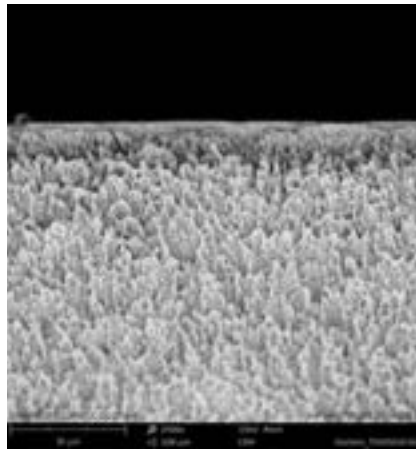
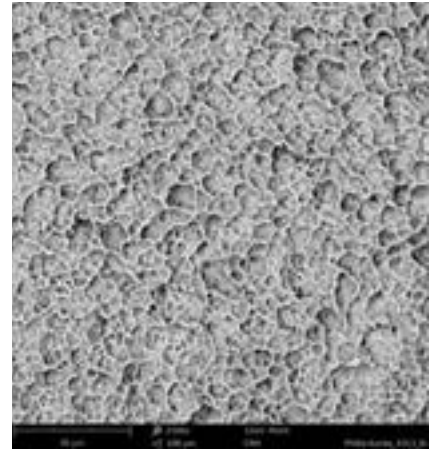
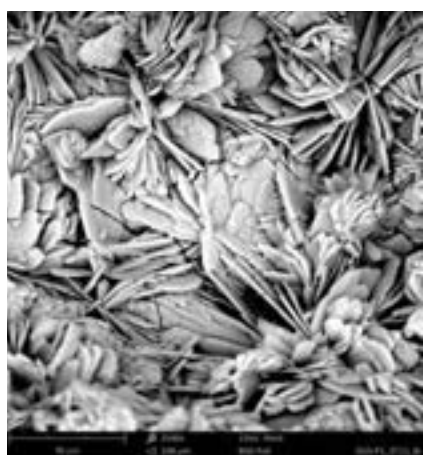
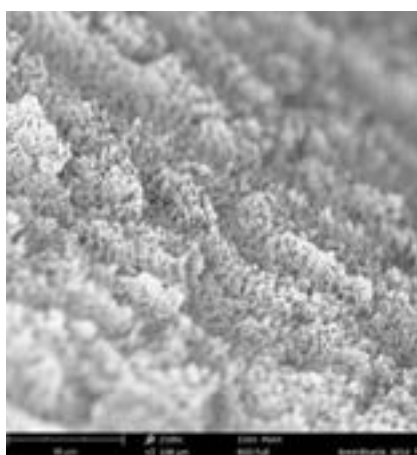
33 | AlphaBio – SPI Spiral Implant (x2,500).

34 | Argon Medical – K3Pro Sure (x2,500).

35 | Avinent – Ocean (x2,500).

36 | C-Tech – Esthetic Line (x2,500).

37 | Dentium – Superline (x2,500).

38 | Nucleoss – T4 Implant (x2,500).

39 | Osstem – TS III (x2,500).

40 | Phibo – Aurea (x2,500).

Fortunately, the vast majority of the studied implants exhibited no significant contamination. By way of example, the surfaces of titanium implants by some manufacturers (Alpha-Bio, Argon Medical, Avinent, C-Tech, Dentium, Nucleoss, Osstem, Phibo,

41 | SGS – Pi (x2,500).

42 | Bredent – BlueSky (x2,500).

SGS and Bredent) are presented at comparable magnification in Figures 33 to 42. The continuous improvement process in Camlog implants deserves special mention. While the samples analyzed in 2008 showed residues of blasting material on up to ten per cent of the total surface, the figure for 2011 was less than three per cent for the same implant type. In the current study, all three implant models (Camlog, Conelog and iSy) exhibited completely residue-free surfaces in the elemental analysis. Thus, the spectrum of the EDX analysis of the Conelog implant surface indicates only titanium (Figs. 43 to 45).

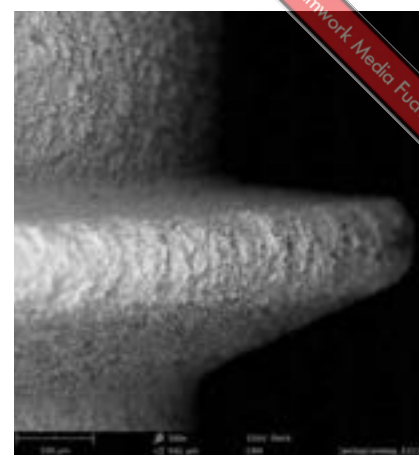
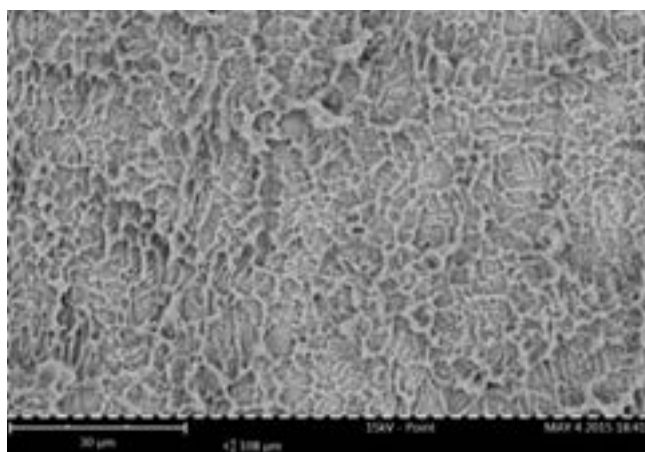
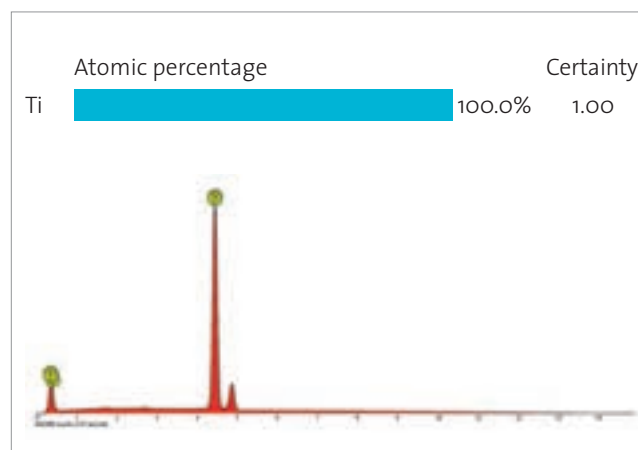
43 | Camlog – Conelog (x500).

44 | Camlog – Conelog, EDX area analysis (x2,500).

45 | Quantitative and qualitative elemental analysis of the Camlog Conelog implant surface (pure titanium).

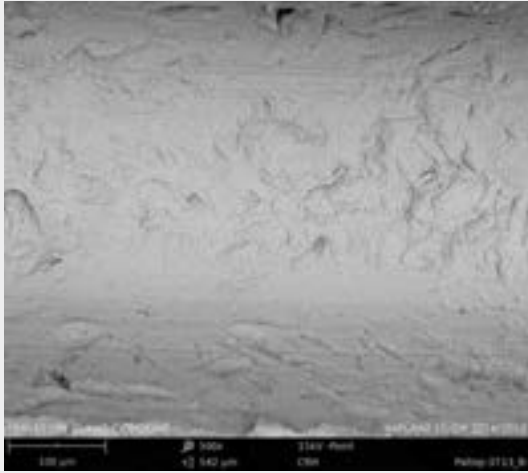
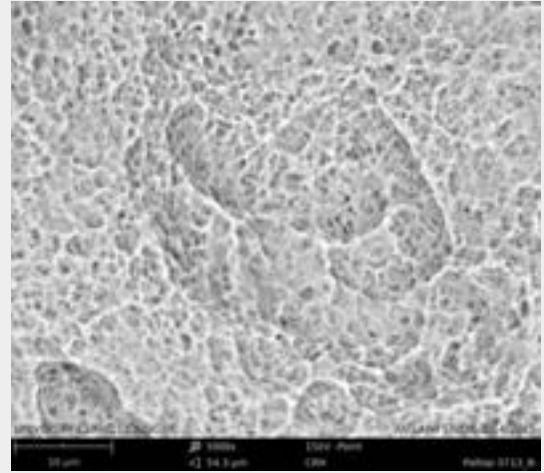
46 | Paltop Advanced Dental Implant (x500).

47 | Paltop Advanced Dental Implant (x5,000).

Only X-ray photoelectron spectroscopy (XPS) can produce such sensitive evidence in layers 5 to 10 nm in thickness. The kinetic energy of the photoelectrons of an atom is measured to determine its binding energy, which is characteristic of the atom from which the electron emanates. This can be used to determine whether the cleaning process after acid etching of the implant surface has left traces of acid or if the water used for the cleaning itself was clean enough. An Israeli manufacturer (Paltop) has decided to consistently clean their products with ultra-pure water (UPW), which is rather expensive to produce compared to regular demineralized water and is otherwise mostly employed by the semiconductor industry. XPS analyses of the implant surfaces thus cleaned show no traces of sulphur, silicon, zinc or chlorine, inorganic impurities not infrequently found in the XPS analyses of the sandblasted and acid-etched surfaces of implants by other manufacturers investigated in 2014 as the corresponding ISIS identification cards were prepared [22]. The material contrast image showed no residue on the Ti-6Al-4V ELI implant (Figs. 46 and 47). The corresponding EDX analysis shows only the typical elements for grade 5 titanium (Fig. 48 and Table 5).

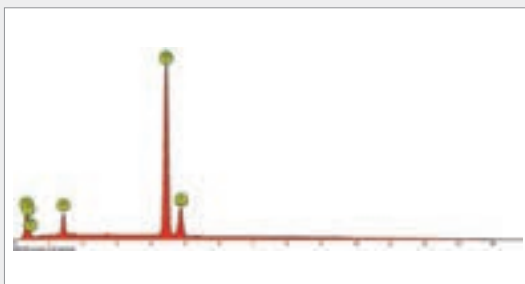
48 | EDX spectrum for the Paltop implant.

Atomic percentage	Certainty
Ti	65.6%	1.00
O	24.4%	0.96
Al	7.3%	0.99
V	2.7%	0.96

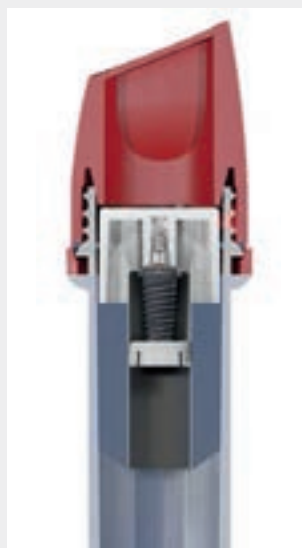
On the one hand, there are uncompromising elaborate constructions that offer safe handling and are sure to eat into the manufacturer's profit margin (Fig. 49). The illustration shows a complex packaging design where the implant is inserted in a separate sleeve made of the same material (grade 5 titanium) as the implant itself to reduce the influence of other materials to a minimum.

49 | Example of elaborate sterile packaging, longitudinal section (Paltop).

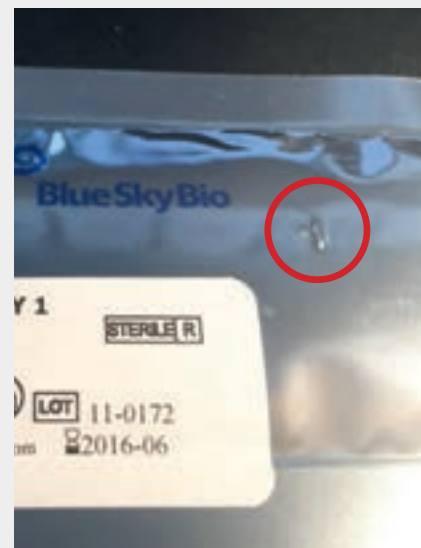
On the other hand, there are simple packaging solutions where the implant is simply sealed in a double plastic bag and the manufacturer seems to have deemed even a stabilizing outer wrapper such as a blister pack to be too costly. Figure 50 shows a sterile package compromised by a sharp-edged cover screw.

50 | Sterile packaging compromised by a sharp-edged cover screw (BlueSkyBio).
